ENERGY EFFICIENCY STUDY AT EL ARENAL DRINKING WATER FACILITY (PAITA – PERU)

FINAL REPORT

July 2005

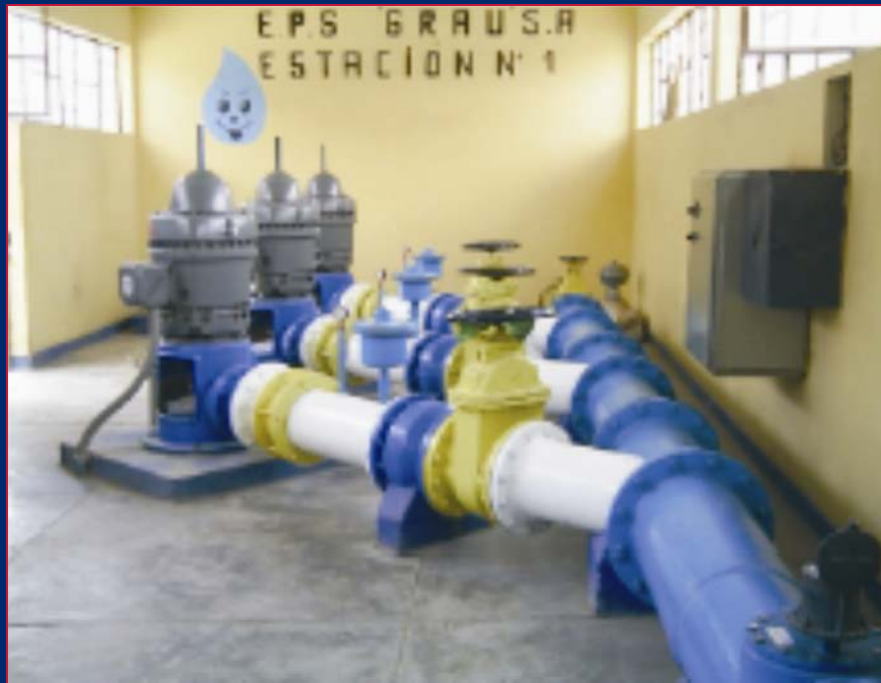
COVER PHOTO

Arrangement of pumps at El Arenal pumping station N° 1.

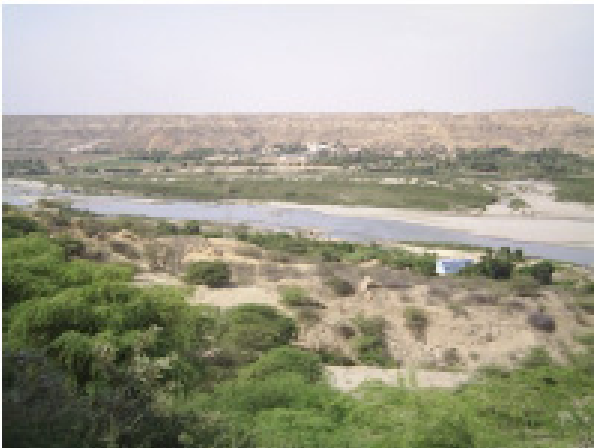
A view of the El Arenal raw-water pumping plant

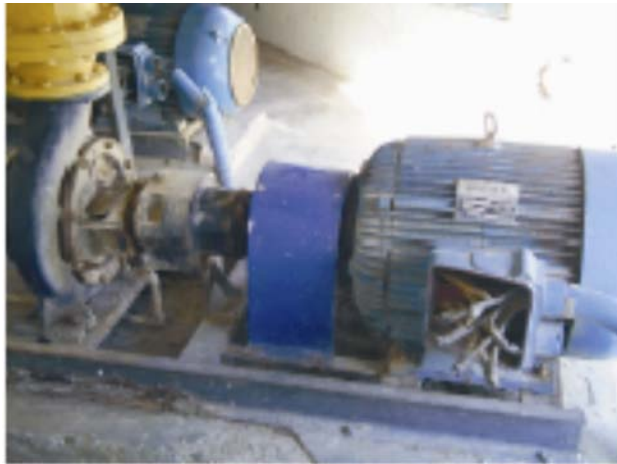
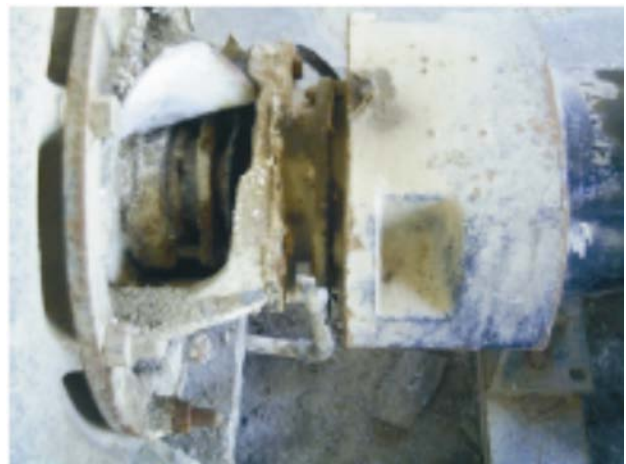
A thorough walk-through of the five main pumping units and of the Paita distribution system revealed two major problems. First, a general lack of adequate maintenance, mainly as a result of insufficient budgets, has left many systems or units in very poor operating condition, as shown in the photos below.

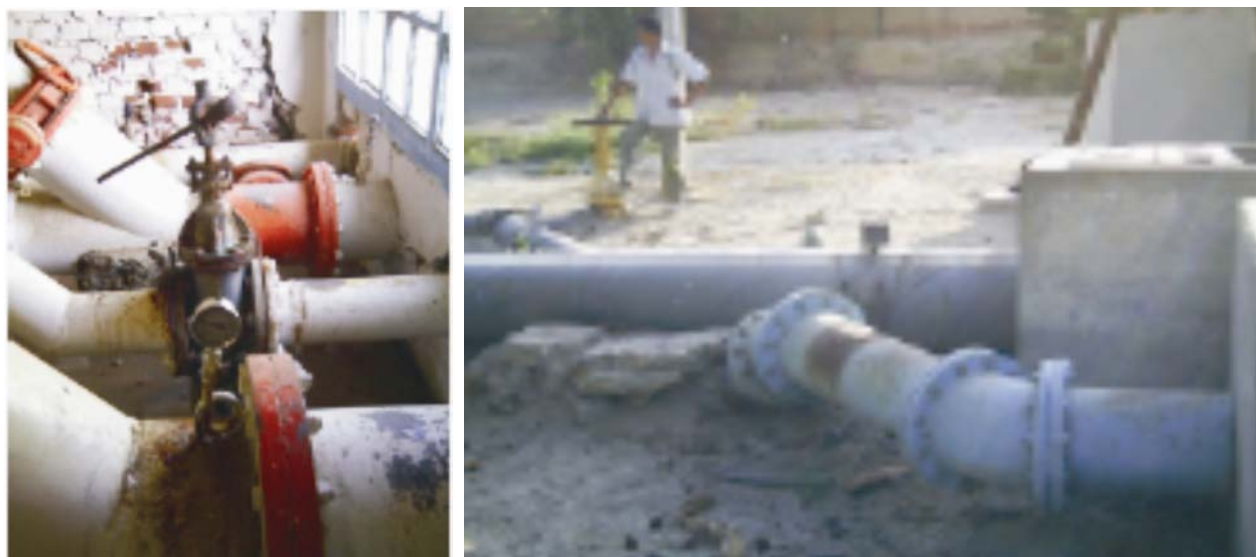
Second, a several major design and repair anomalies were observed, all leading to poor energy performance (see photos below).

Based on our three weeks of field work, we rank the overall condition of the electrical installations from bad to average.

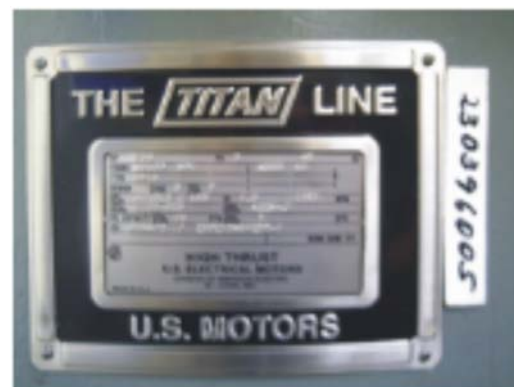
In a case of electricity supply interruption, there is currently no emergency electricity-generation set-up. Guaranteeing a continuous supply of drinking water to the people of Paita and Talara, including during energy service interruptions in ENOSA, will require having emergency generation sets in the collection and water treatment plants and pumping stations of Paita and Talara.
